Discolouration of coated joinery

Causes and solutions

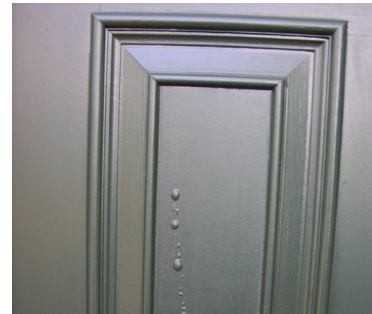
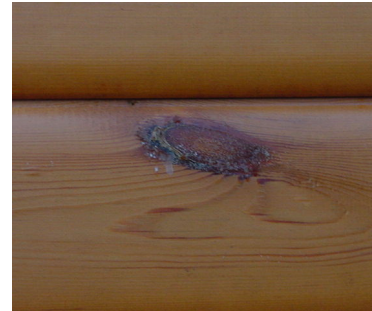
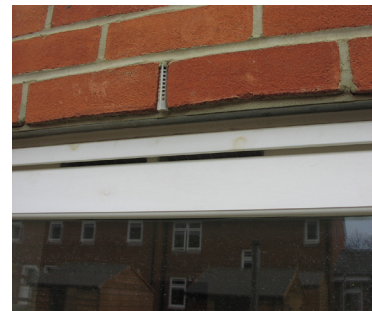
Staining of opaque coated joinery is a more complex phenomenon, and generally results from two main sources: soluble extractives or tannins; and resins, both of which are naturally present in timber. Tannins are the main cause of staining in hardwoods, whilst resin exudation tends to be more prevalent in softwood varieties, particularly around knots.

As well as timber species, the severity of staining is also influenced by the following: - growing region; knots; preservation treatment; processing and exposure conditions. Moisture plays a major part in tannin migration through the coating system and site problems occur most often when dry joinery from the factory is exposed in warm moist conditions: the rapid uptake of moisture as the joinery conditions tends to mobilise the resin and tannins whilst heat and sunlight draw them to the coating surface.

Milky discolouration in translucent systems can happen in cold conditions, when the joinery has been wrapped or is stored in damp conditions. This discolouration will disappear within a few days of the joinery being installed as the residual moisture dissipates to atmosphere and the coating achieves full cure. For opaque systems the issue will show itself as micro blistering, but in severe cases the blisters can be much larger. Again, these will disappear as the moisture dissipates to atmosphere.

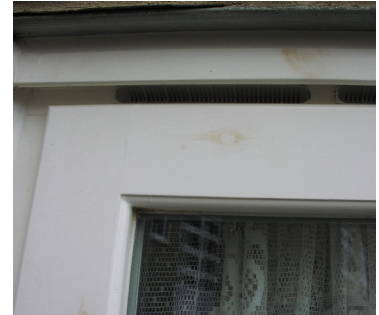
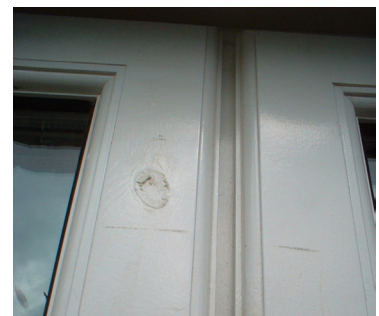
In addition to soluble extractives, the cell structure of wood contains groups of chemicals, often referred to as exudates. In softwoods, the principle exudate is referred to as resin and can show itself in coating discolouration, viscous liquid or crystalline solids on the surface of the timber or coating, or a combination of both.

Resin staining and exudation is commonly seen at knot margins, but is also found in resin ducts and sometimes on latewood bands. Timber species, age, growth conditions, season of harvest, the ratio of sapwood to heartwood and the number of live knots all have an influence.

The staining associated with resin is chemically different from the tannin stains of hardwoods and many hardwood isolating primers offer relatively ineffective protection against resin staining.

Resin exudation is usually initiated by a combination of heat and moisture, which changes the resin from a solid to a liquid and in severe cases to a gas. In joinery processing, drying equipment, heated storage, stretch wrap packaging, and heating systems in buildings post fitting are common initiators.
